## 1. Introduction

This general service information wants to put extra attention on the handling of the backcover while closing the TV after repair. This to prevent audio protection due to possible bad contact.

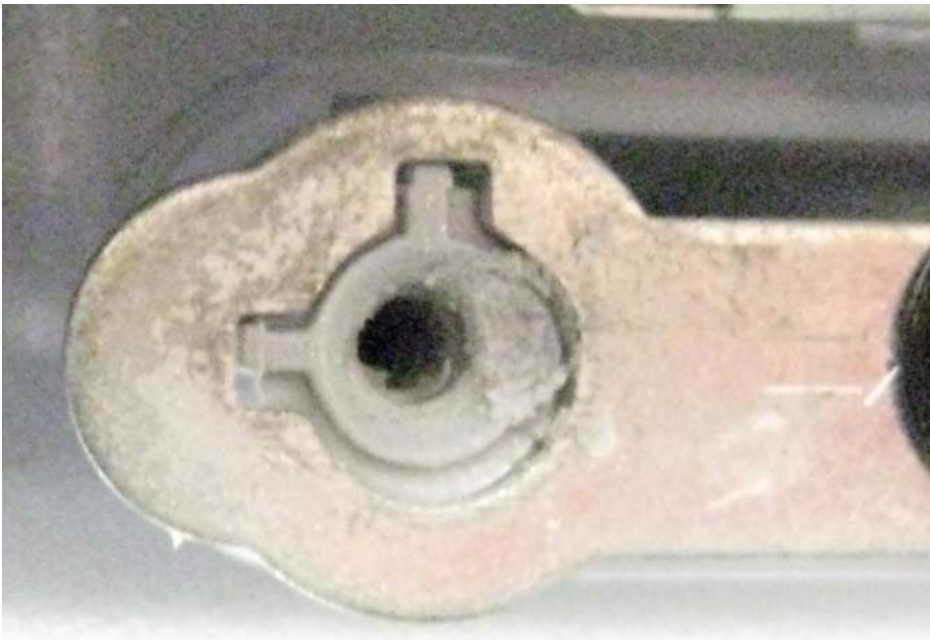
Fig. 3 Damaged screw hole.

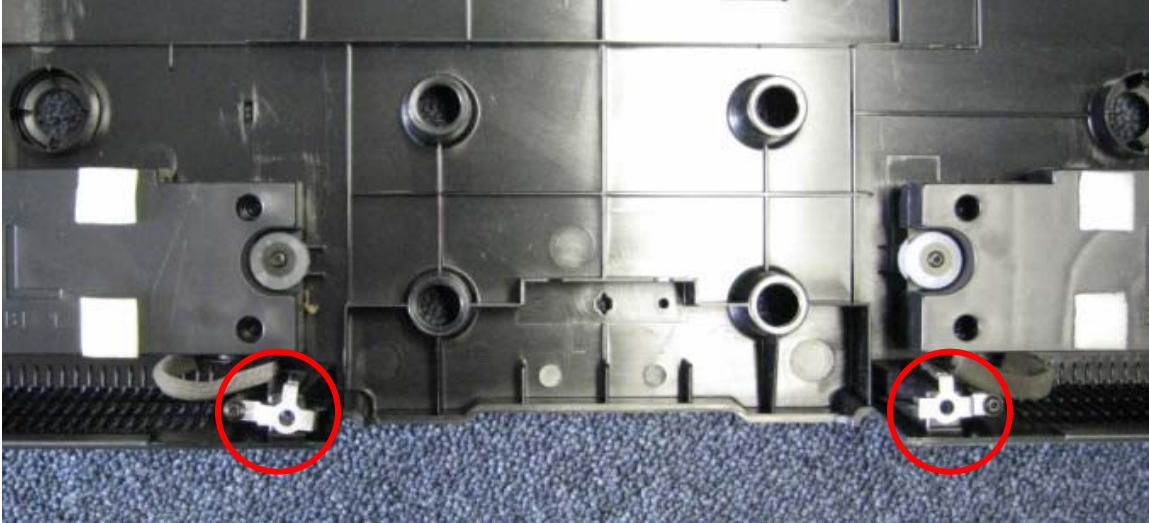
Fig. 4 Check contact lip positioning.

a) Control both positions at the backcover if metal lips are positioned well.

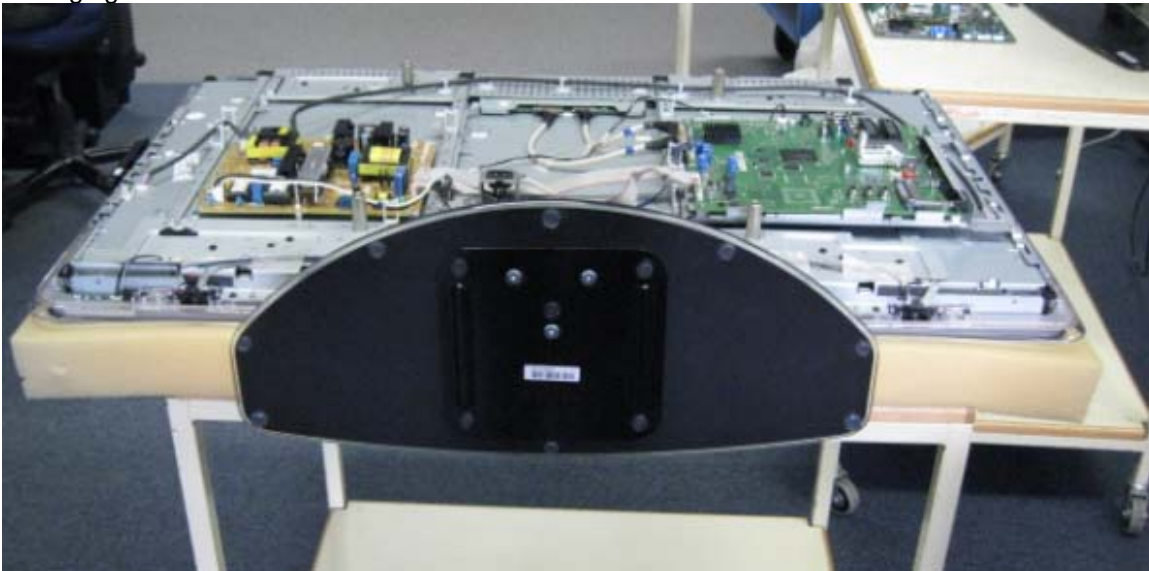
Fig. 5 TV placement.

b) Put the TV set onto a horizontal surface protected with foam to prevent the display from damaging:
