1. Introduction

This general service information wants to put extra attention on the handling of the backcover while closing the TV after repair. This to prevent audio protection due to possible bad contact.

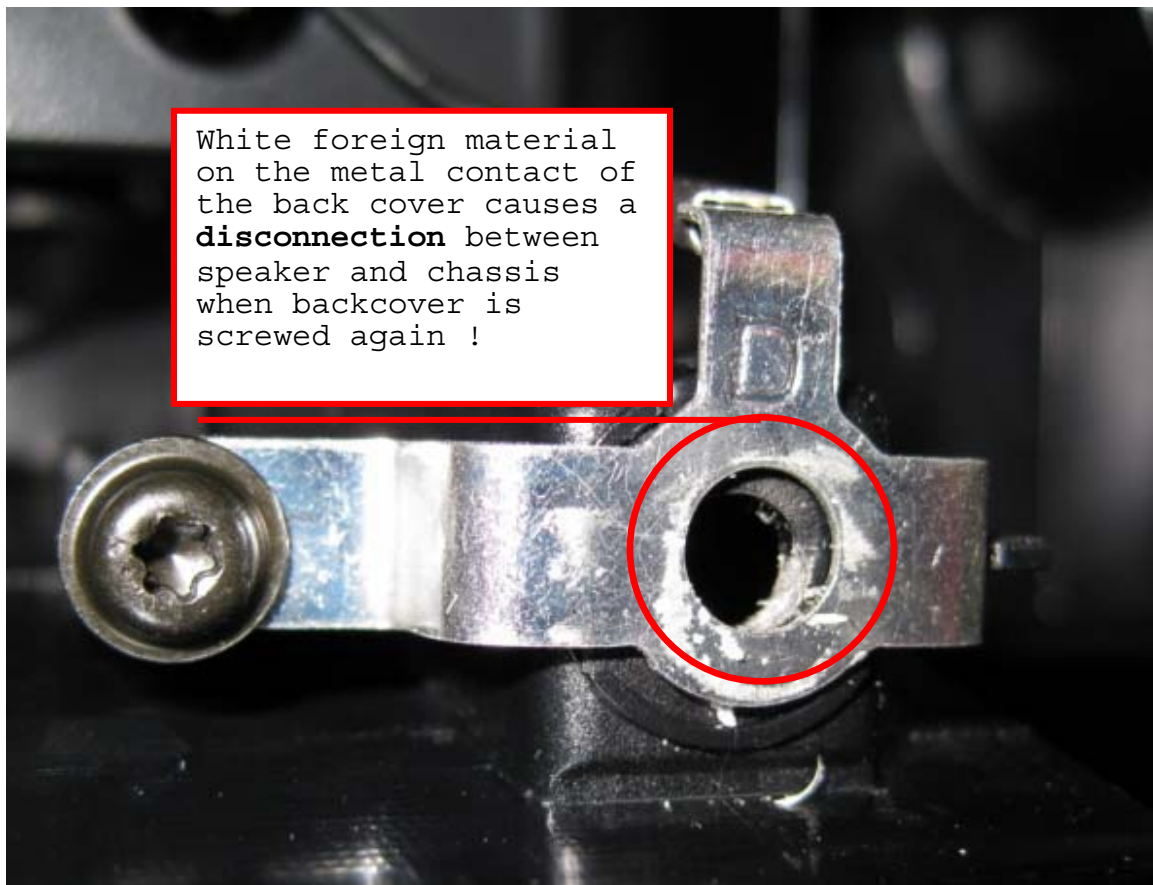
- a) Screwholes damaged due to foreign material stuck on the metal contact.
- b) Screws not well tightened so that there is bad contact.
- c) Once the set is closed, the metal lip is damaged and doesn't make contact with the chassis anymore.

This can result in the TV not starting up, error protection, and broken audio amplifiers!

Fig. 1 Foreign material on the metal contact.

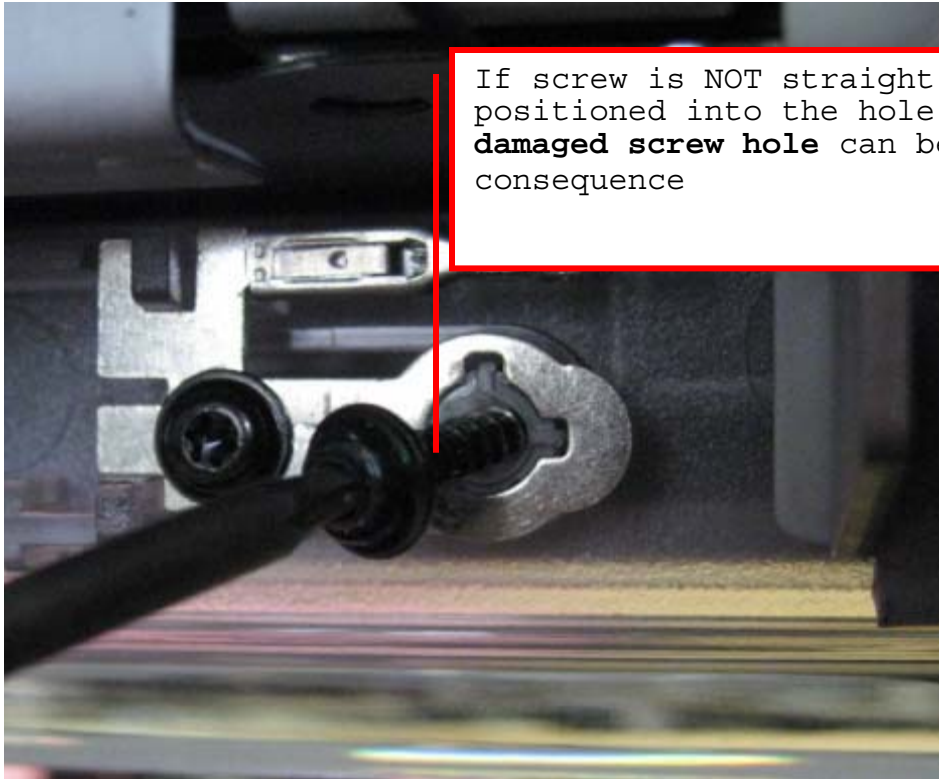
Fig 2 Screw not perpendicular to screw hole fastened.

c) Position the screws that close the backcover straight into the screw holes (perpendicular to), and make sure that the screws are well tightened.

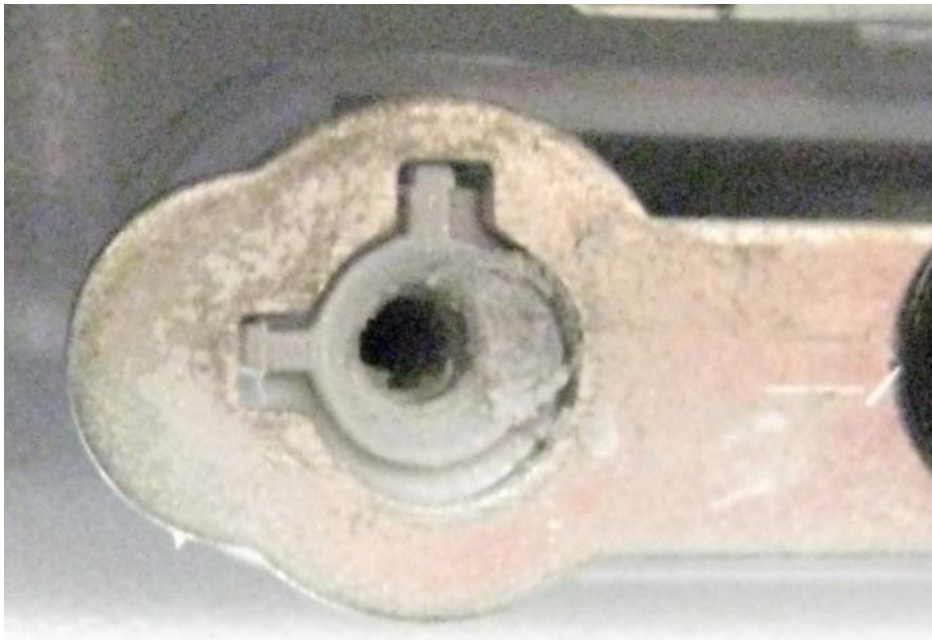
Fig. 3 Damaged screw hole.
