JVC Service Bulletin

SUBJECT: TO IMPROVE PICTURE AND SOUND NOISE

DATE: MARCH, 2005

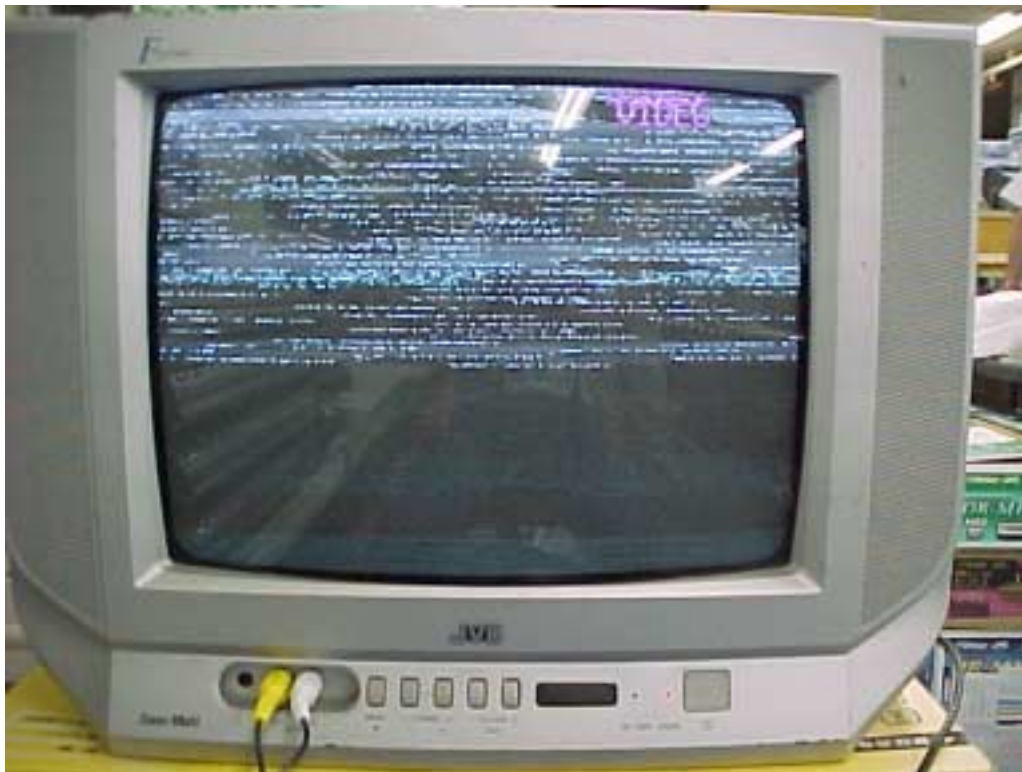
After make the power on mode for a while, the green or white noise and sound noise occurs and then become the loading sutiation.

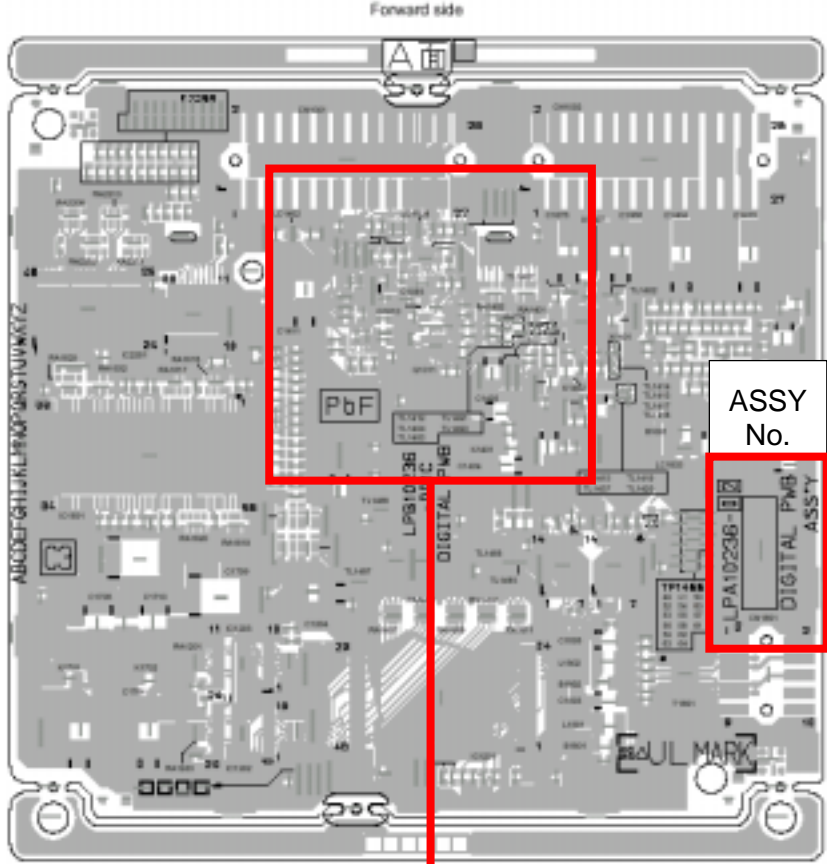
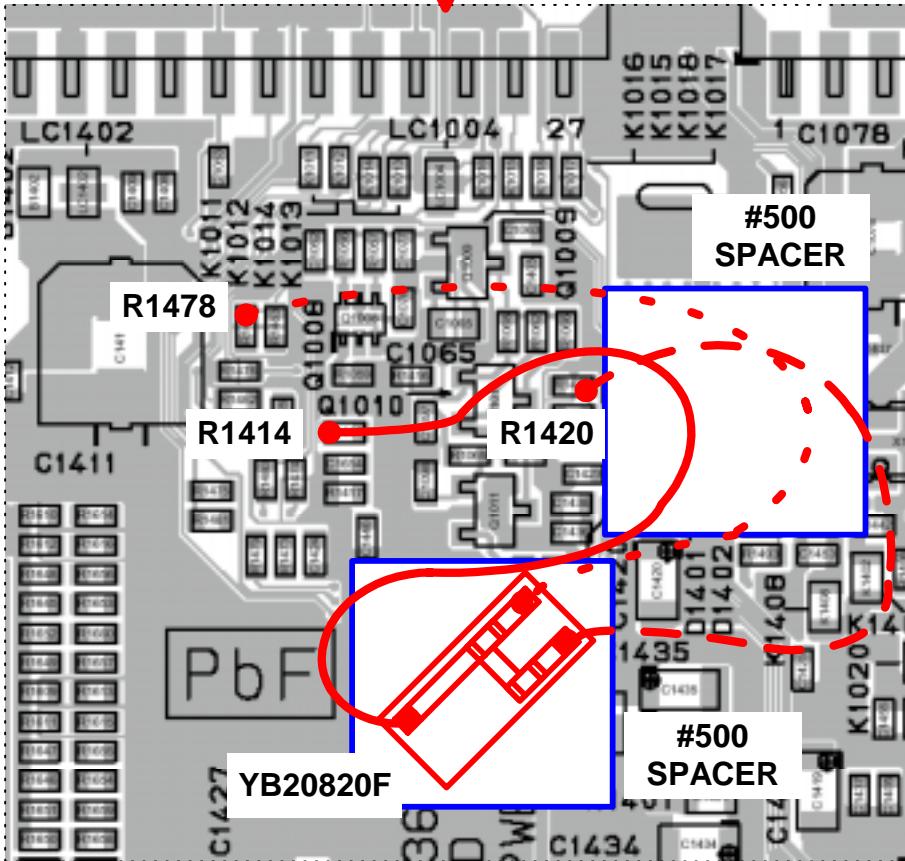
The clock of some type of IC1401 (DIGITAL BOARD ASSY) is unstable.

A) Add a SUB PWB ASSY (YB20820F1) on the DIGITAL BOARD ASSY as shown below.
#500SPACER: PU59915-105(100pcs/1sheet)
