LCD COLOUR TELEVISION

**TECHNICAL REPORT**

No power (LCD power unit failure)

Date : Revised on February 13, 2004  
No. : LV-088From : Quality & Reliability Control Center  
AUDIO-VISUAL Systems Group

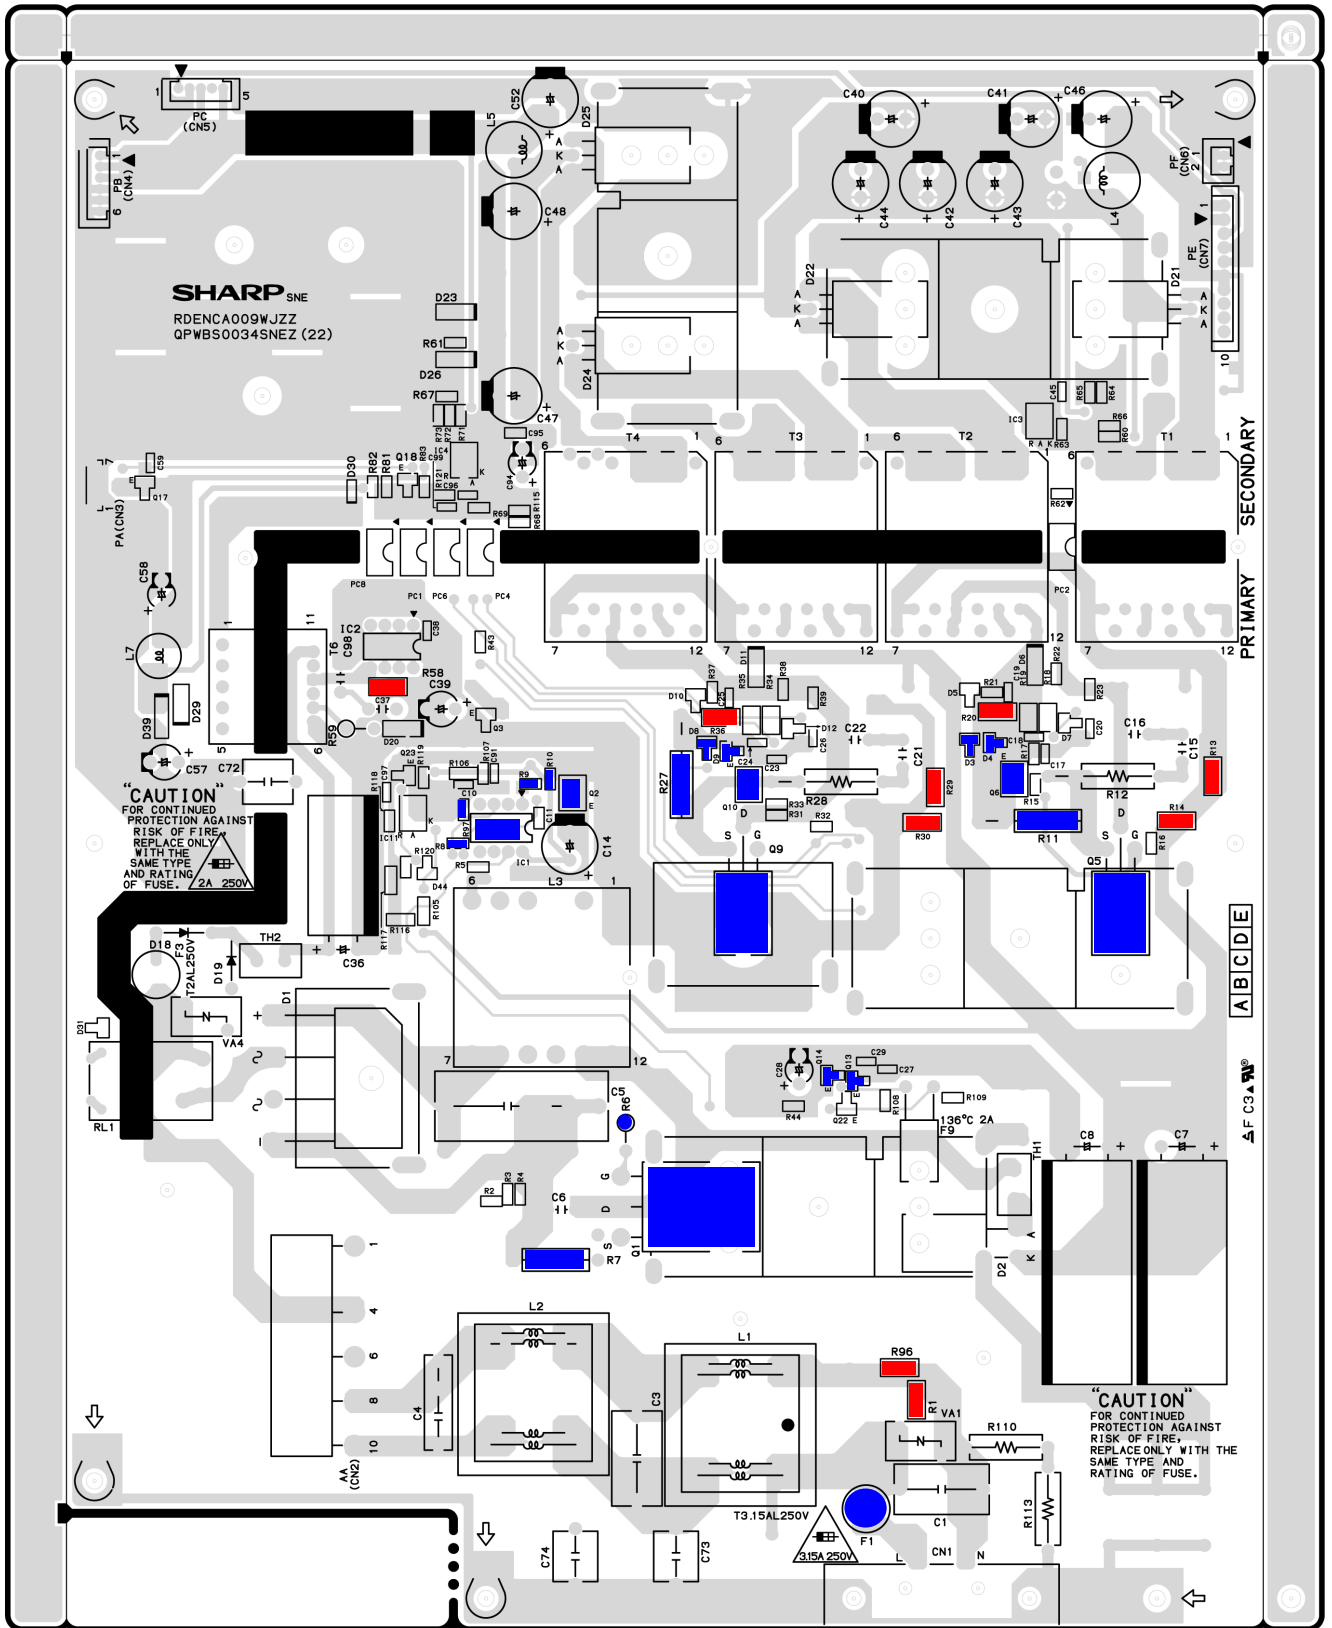
LCD POWER UNIT (RDENCA009WJ\*\*)

General	Please note this service information for your service.
Model	LC-30HV2E, LC-30HV2U, LC-30HV2M, LC-30HV4U
Phenomenon	No power (LCD power unit failure) LCD power unit: RDENCA009WJ**
Cause	Damage of some components (Q5, components on the peripheral circuit of Q5/Q1) caused by solder crack on 5025 type chip resistor
Servicing	In this case, please take the following steps. 1. Add solder to both ends of the following resistors (9 pcs.): R1, R13, R14, R20, R29, R30, R36, R58, R96 2. Replace the following components with new one (22 pcs.): F1, R6, R7, R11, Q1, Q5, Q6, Q13, Q14, D3, D4, IC1, R27, Q9, Q10, D8, D9, R8, R9, R10, R97, Q2

- Adding solder
- Replacing with new one
